Inner-Bank Erosion Processes and Solutions at Coastal Inlets

by William C. Seabergh

1. REPORT DATE SEP 2002		2. REPORT TYPE N/A		3. DATES COVERED -	
4. TITLE AND SUBTITLE Inner-Bank Erosion Processes and Solutions at Coastal Inlets (ERDC/CHL CHETN-IV-52)				5a. CONTRACT NUMBER	
				5b. GRANT NUMBER	
				5c. PROGRAM ELEMENT NUMBER

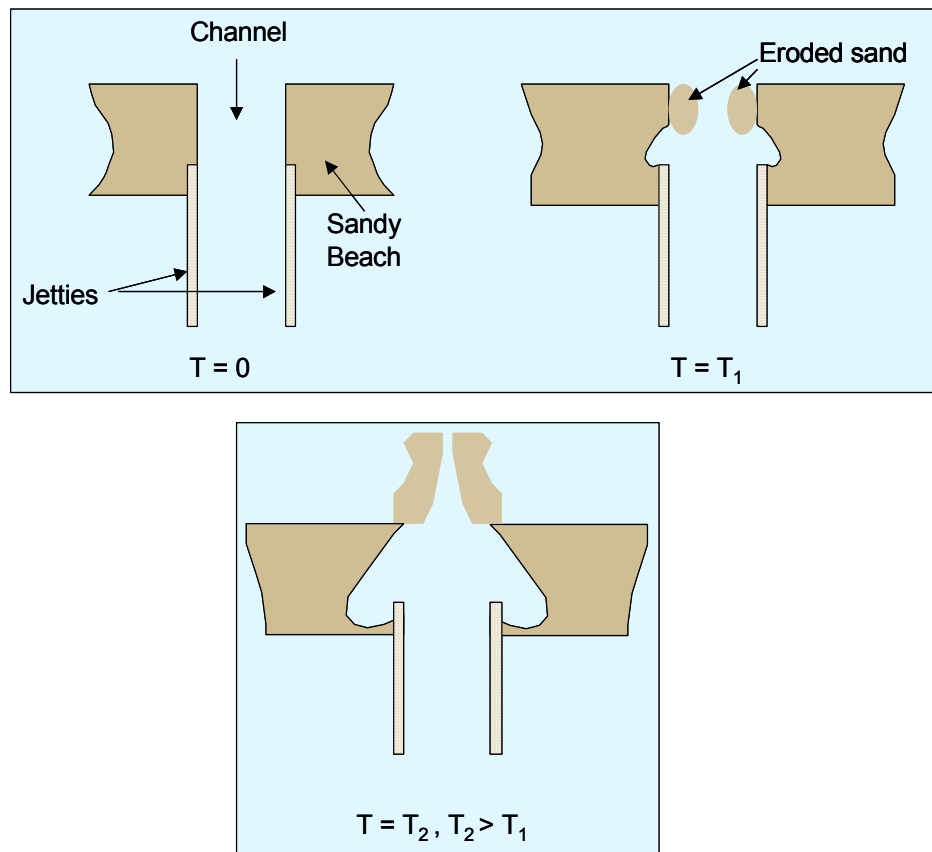
Figure 1. Sequence of inner-bank erosion over time, from time $T = 0$ to time $T = T_2$

BACKGROUND: Jetties at inlets often terminate in the alluvial soil of the barrier island or mainland of the entrance that they stabilize. The termination area, exposed to waves and currents, is frequently observed to erode (Figure 1). If erosion is permitted to proceed unabated, a crenulate-shaped shoreline region will develop from the terminus of the jetty, extending both bayward and laterally into the adjacent beach. The expansion of erosion leads to loss of property and difficulties in reclamation if a shallow-water environment develops. The eroded sediment may move into the channel, contributing to shoaling.

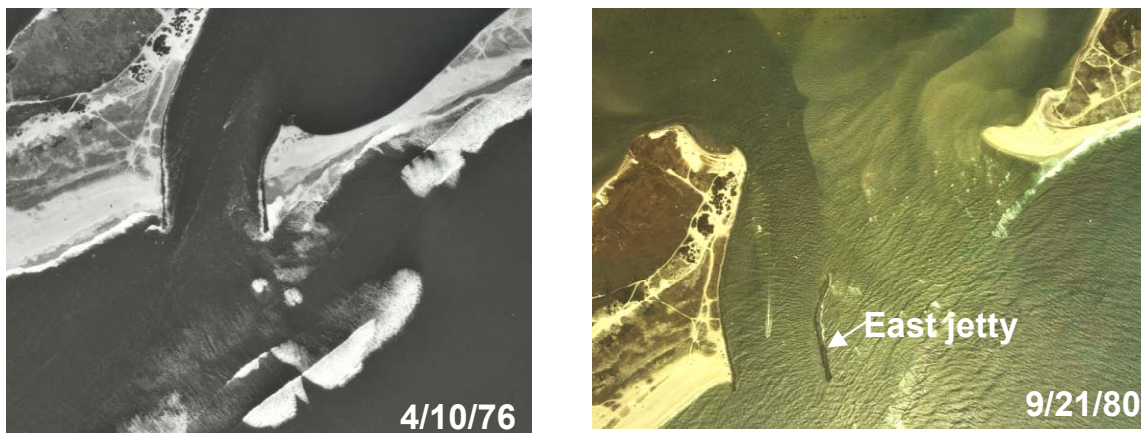
Figure 2. Left panel shows Moriches Inlet, NY, before it breached on 15 January 1980. East jetty was flanked, after it breached, as shown in the right panel

The eroded region may flank the jetty, leaving it isolated from the shore. Figure 2 shows an example before and after breaching. This breaching at Moriches Inlet, NY, has been described by Sorensen and Schmelz (1982). Isolation of the jetty may lead to potential problems of tidal current scour near the structure, opening the already eroded embayment to increased wave activity and additional erosion, and permitting increased wave attack on the jetty itself. As part of the Coastal Inlets Research Program (CIRP) being conducted at the U.S. Army Engineer Research Development Center (ERDC), Coastal and Hydraulics Laboratory (CHL), erosion at the bay side of jetties was studied in a movable bed physical model of an inlet. After the governing processes were understood, preventive techniques were investigated.

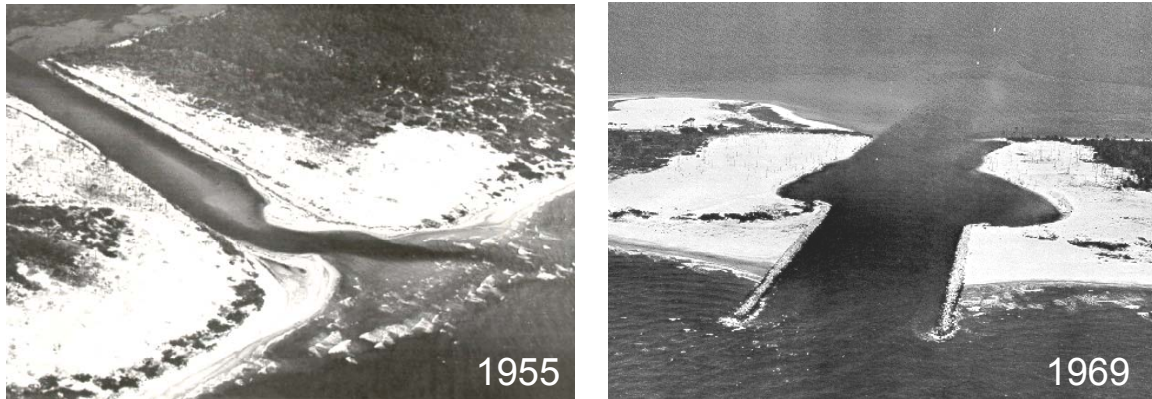
Figure 3. Before and after jetty construction at St. George Inlet, FL, on Gulf Coast

Erosion occurred at St. George Inlet, located on the Gulf Coast in the eastern part of the Florida panhandle. Figure 3 shows the inlet in its natural state (left panel), and the right panel shows the inlet 12 years after parallel jetties were constructed. An erosive force created the curved shorelines at the base of the jetties. Figure 4 shows the entrance channel at Panama City Harbor, FL, created by cutting through an elongated spit in 1933. The construction included jetties extending to the -3.7-m-mllw (mean lower low water) contour. The inner 90 m of the jetties flared outward and were anchored in sand. Between 1935 and 1956, landward extensions of the jetties were made to prevent continued erosion of the inner-bank shoreline. Flanking of the jetties was a major concern.

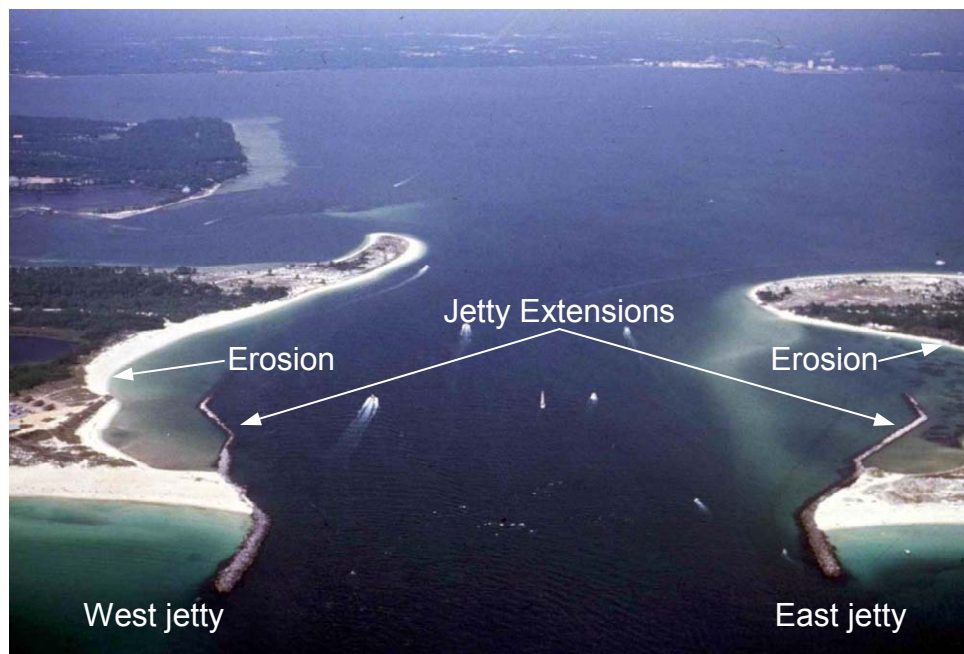
Figure 4. St. Andrews Bay Inlet (Panama City, FL) 1992. Jetty extensions added to prevent flanking

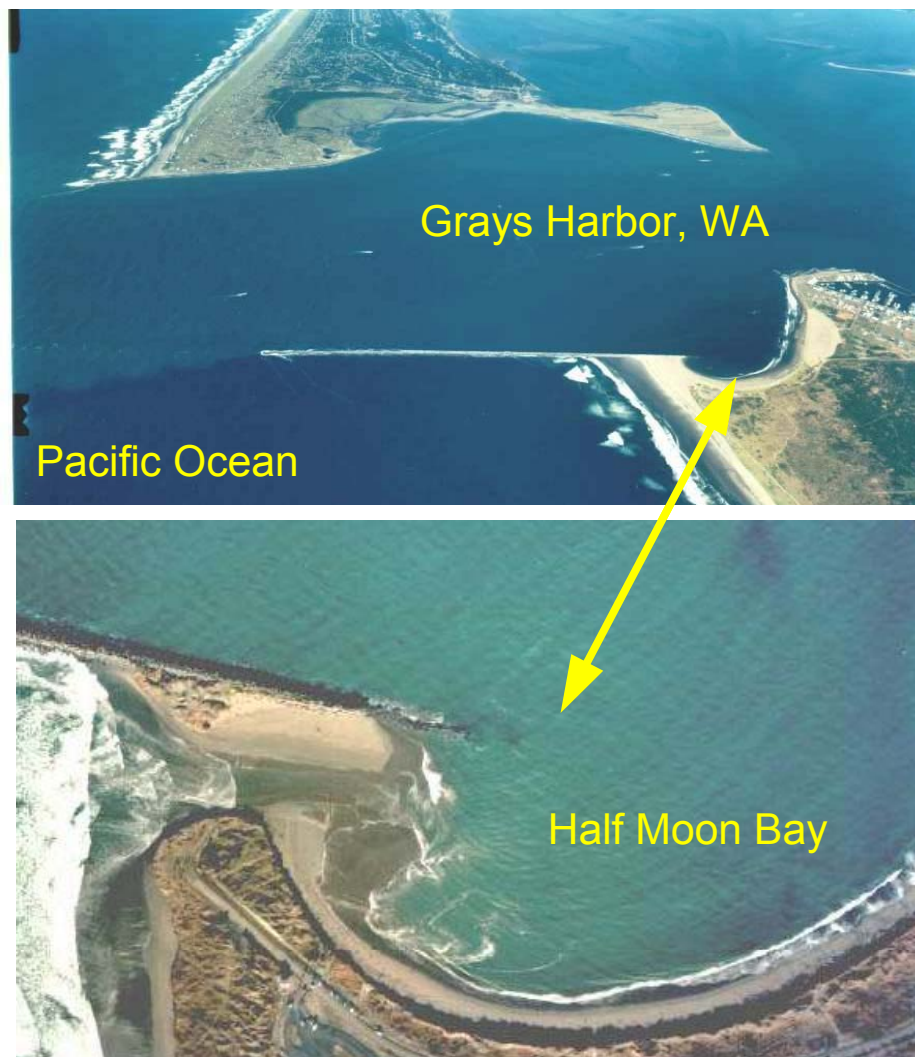
Figure 5. Jetty flanking at Half Moon Bay, Grays Harbor, WA

Figure 5 shows flanking of the south jetty at Grays Harbor, WA. The region behind the shoreline is called Half Moon Bay. This “bay” was created after the south jetty was raised from +3.65 m mllw to +6.10 m mllw. With the jetty at the +3.65-m elevation there was continual sand transport from the ocean shoreline to the region inside the inlet, probably due to the strong wave climate of the region pushing sediment over the landward intersection of jetty and beach. After the jetty was raised, the sediment supply was cut off and creation of Half Moon Bay began. The jetty was raised in 1936, and by 1993 the distance between the beach and Half Moon Bay was short enough that a winter storm caused a breach or flanking of the inlet (Seabergh 1999b).

In late 1993, the region just south of the south jetty was breached during a storm (Figure 5), and emergency measures had to be taken to repair the breach. The navigation channel was in close proximity, located on the inner edge of the south jetty, and tidal flow could potentially enlarge the breach and cause additional erosion to the region. Increased exposure to wave action was also a possibility for the city of Westport, located east of the eroded area. The ocean-side beach had also been receding, so the combination of inner-bank erosion and beach recession had greatly increased the potential for breaching. The gap was filled with dredged material in this emergency. As part of a plan to reduce likelihood of future breaches, the U.S. Army Engineer District, Seattle, designed a mound structure based on the conceptual model experiments of CIRP as previously described. A model study was conducted to replicate the shoreward region of the south jetty and some of the navigation channel in the laboratory facility. This work validated the design. Figure 10 shows the initial condition as shown in the model and the plan selected for construction. The wave angle sweeping along the shoreline is modified by the mound, directing it more perpendicular to the inner bank shoreline. Also, wave heights were significantly reduced in this region. Figure 11 shows the structure shortly after construction in August 2000.

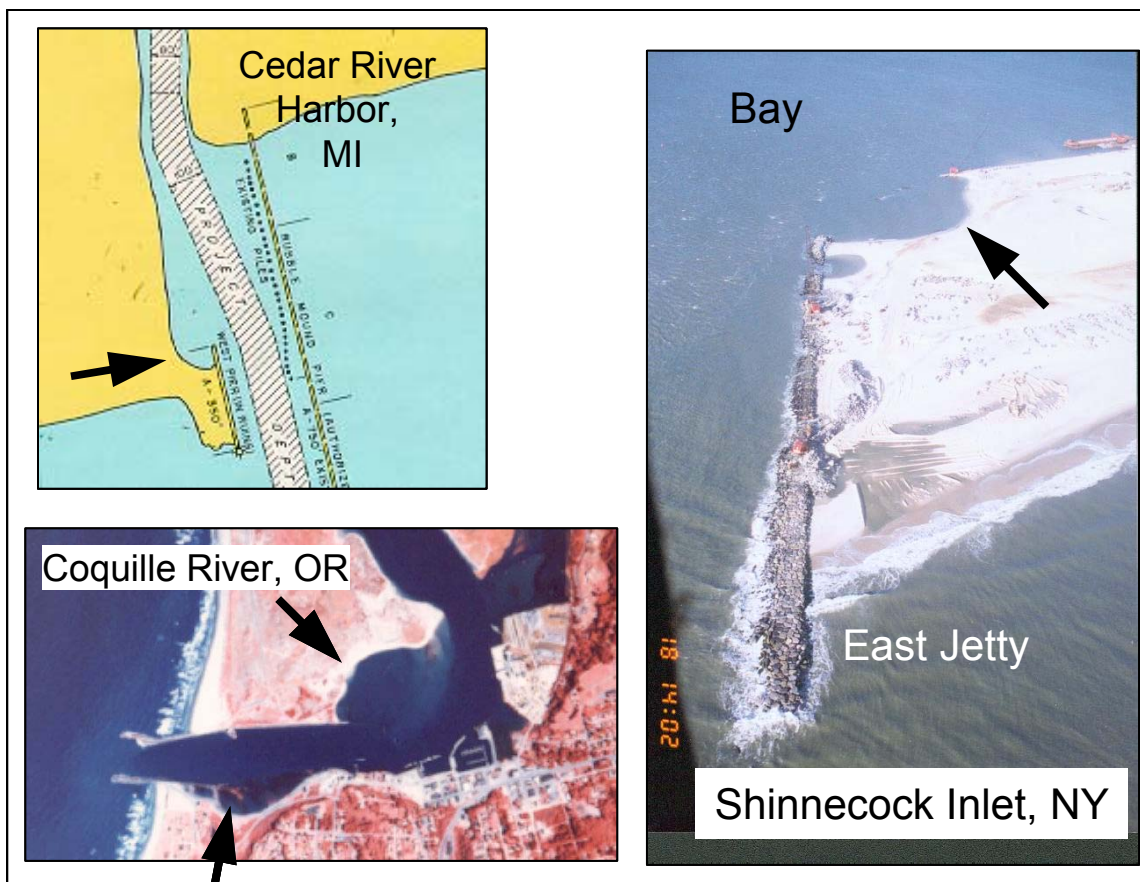
Figure 6. Examples of inner-bank erosion at coastal inlets on Atlantic, Pacific, and Great Lakes coasts

This commonly occurring recession of the inner bank of an inlet is found at jetties on all United States coasts, including the Great Lakes (Figure 6). The basic condition necessary for this erosion to occur is the termination of a jetty in a sandy area that is not receiving any sediment into the local region of the jetty termination. The forcing mechanisms are discussed next.

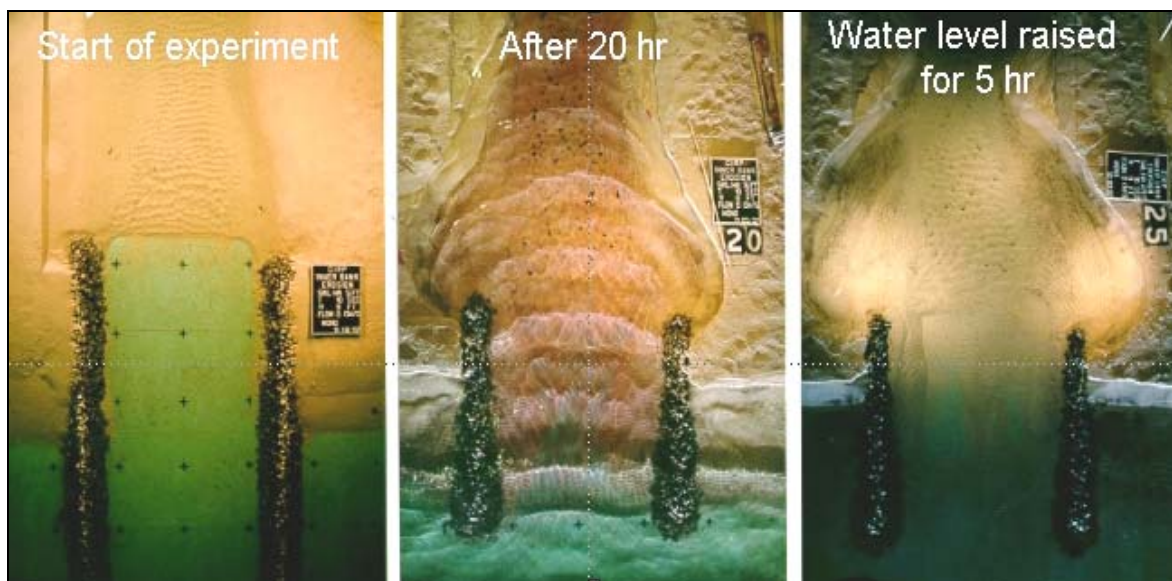
Figure 7. Physical model experiments showing inner-bank erosion development

The erosion region developed from a straight bank line into the crenulate shaped embayments as seen in Figure 7. It reached an equilibrium shape after about 20 hr model time. Raising the water level with the same incident wave conditions produced a greater erosion area (right side of Figure 7). The addition of currents with the waves increased the size of the embayment, but the initiating process was observed to be the same as the no-current experiment. Sediment eroded from the embayment moved along the edge of the inlet channel. With the no-current condition, sediment built out into the center of the entrance channel and reduced the rate of removal from the eroded region. The flood current increased the angle of wave attack and movement of sediment out of the embayment. With a tide-plus-waves condition, a similar shape embayment formed as for previous conditions, larger than the no-current condition, but smaller than the wave-plus-steady-state flood current. The variation in tidal elevation permitted a deeper cut in the embayment. With currents (steady-state or tidal) present, the eroded volumes increased in the range of 8 to 45 percent.

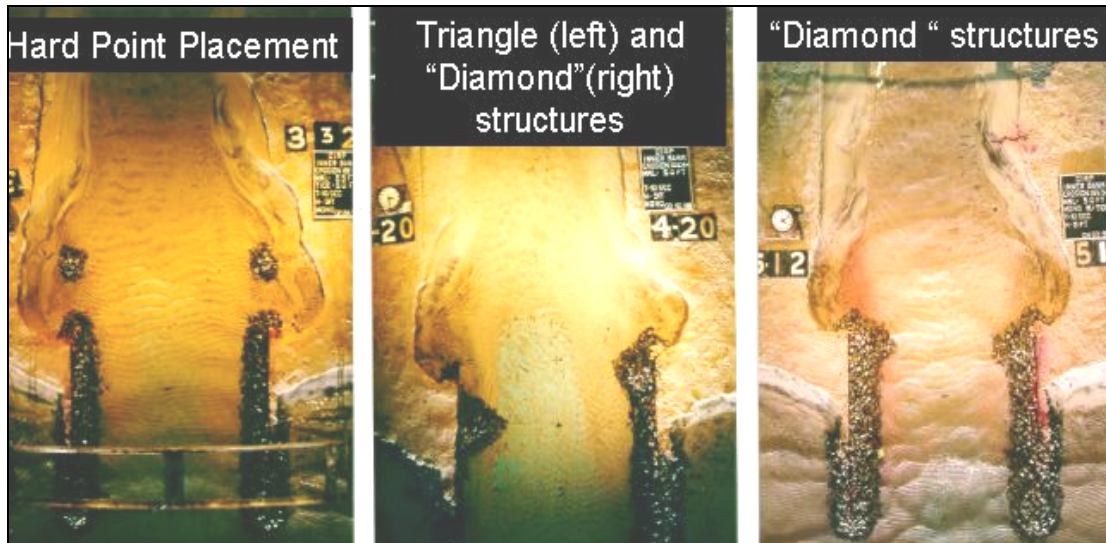
Figure 8. Inner-bank erosion prevention experiments

Inner-Bank Erosion Prevention Methods. Follow-up experiments examined potential solutions to minimize erosion by placing hard points to create smaller embayments or altering jetty structure slope and lateral extension into the channel. A diamond shape (in plan view) was built on the end of the right jetty and functioned to reduce wave energy at the end of the jetty. Because of its extension into the beach, it also prevented flanking, as shown in Figure 8, right side. On the left side of the middle photograph, Figure 8, a channel-side structure is placed seaward from the jetty terminus, and flanking of the jetty occurred because there was no tie-in to the beach. The headland concept was adopted by adding a hard point (a rock mound) on a line bayward of the jetty, to create a smaller embayment region than was created without the additional structure (Figure 8, left panel). These are compared to the nonstructure experiment in Figure 7 for wave and tidal current conditions. Volumes eroded and surface area removed were reduced for the prevention methods. The diamond structure reduced erosion and prevented flanking of the structure, reducing volume loss 58 and 47 percent on the right (initially steep slope) and left (initially relatively flat slope) inner-bank regions, respectively.

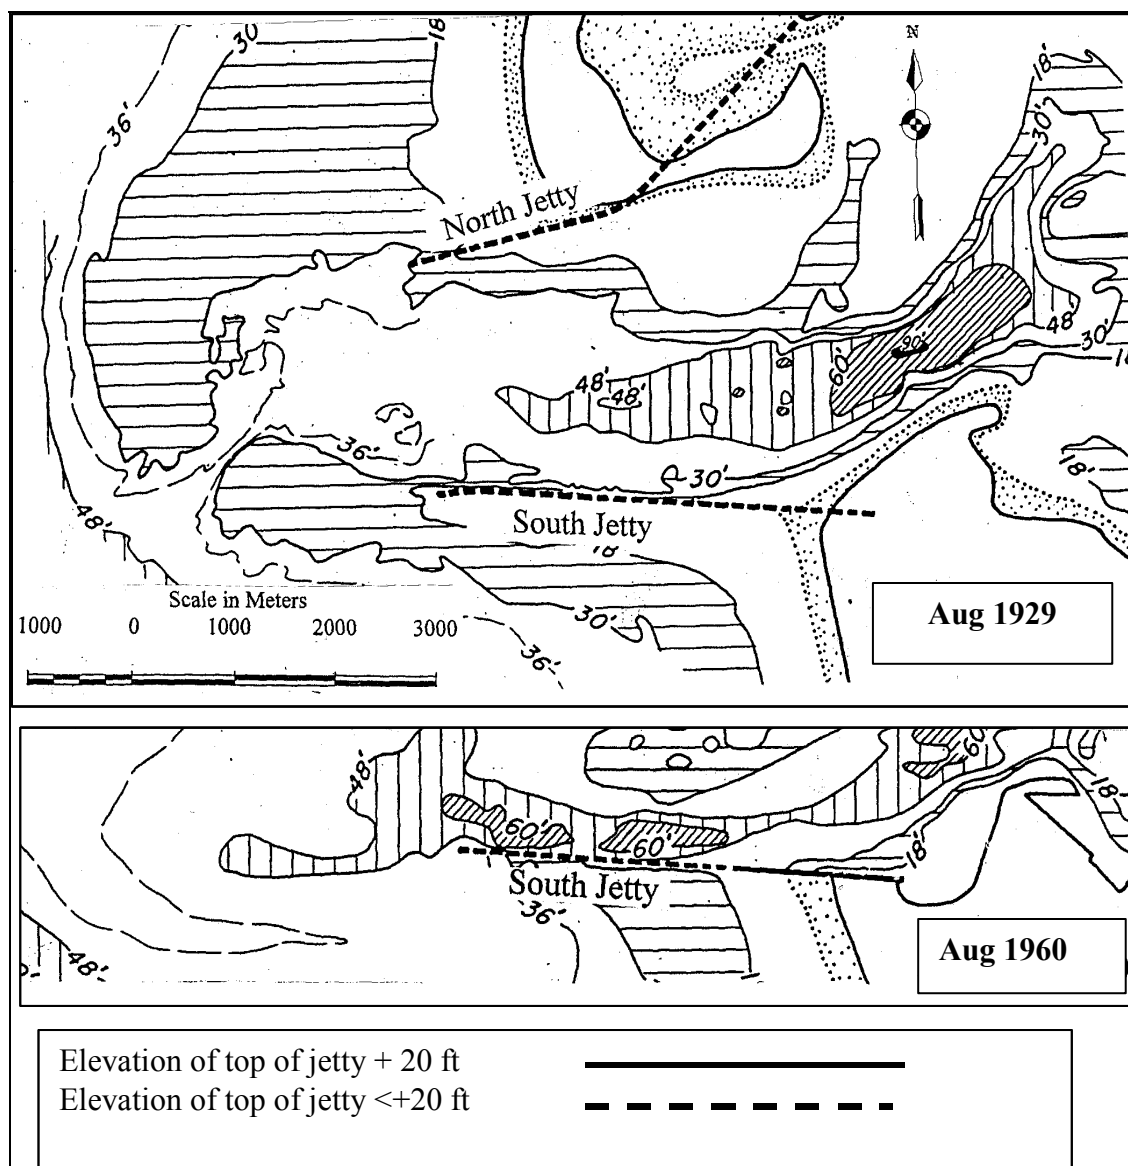
Figure 9. Grays Harbor, WA, entrance channel and adjacent shorelines. August 1929, before south jetty shoreward portion raised, and August 1960, about 24 years after south jetty raised to +6.1 m, mllw. Note inception of inner-bank erosion at landward end of south jetty

FIELD APPLICATION: Referring to Figure 5, Grays Harbor, facing the Pacific Ocean of Washington, has a large entrance channel. South jetty construction commenced in 1898, and north jetty construction was completed in 1913. By 1929, the inlet entrance was as shown in the top map of Figure 9. Focusing attention on the shore end of the south jetty, which had a crest elevation of +2.4 m, mllw, there was a continuous shoreline from ocean side to bay side at the south jetty junction with the shore. Apparently, in this region of severe wave climate (average significant wave height of 2 m, with storm waves of 5 m not unusual) and large tide range (diurnal tide range of 2.7 m), sediment can move over and through the jetty at the shoreline during high water and storm conditions. Earlier maps of the inlet, after the jetties were built, showed this continuous shoreline through the south jetty also.

In the 1936-1939 time frame, the south jetty crest elevation was increased to +6.1 m, mllw. This addition in elevation was sufficient to reduce or cut off the sediment supply from the beaches to the inner-bank shoreline. As seen in Figure 9, initially the inner bank was receding eastward, and by 1946 the jetty terminus was exposed. An eroded region evolved at the south jetty terminus, as seen in the 1960 time frame. In 1960, the curved notch extended approximately 640 m landward from the jetty terminus, and was recessed 200 m laterally into the inner bank. By 1993, the eroded region had increased to dimensions of 730 m long by 275 m wide. From 1946 to 1960, it expanded at a rate of about 46 m/year in length and 14 m/year in width. From 1960 to 1993, the rate of increase decreased significantly.

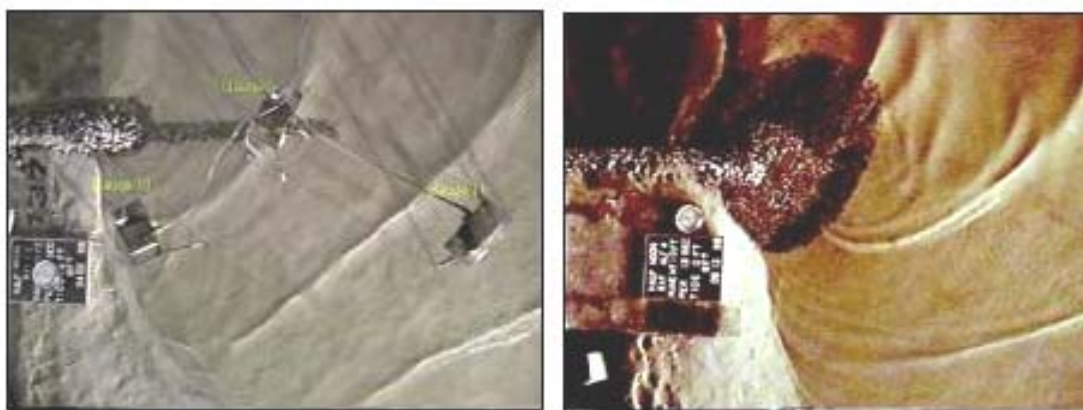
Figure 10. Model study photographs: left picture shows the prediffraction structure condition and right picture shows the mound structure diffracting waves

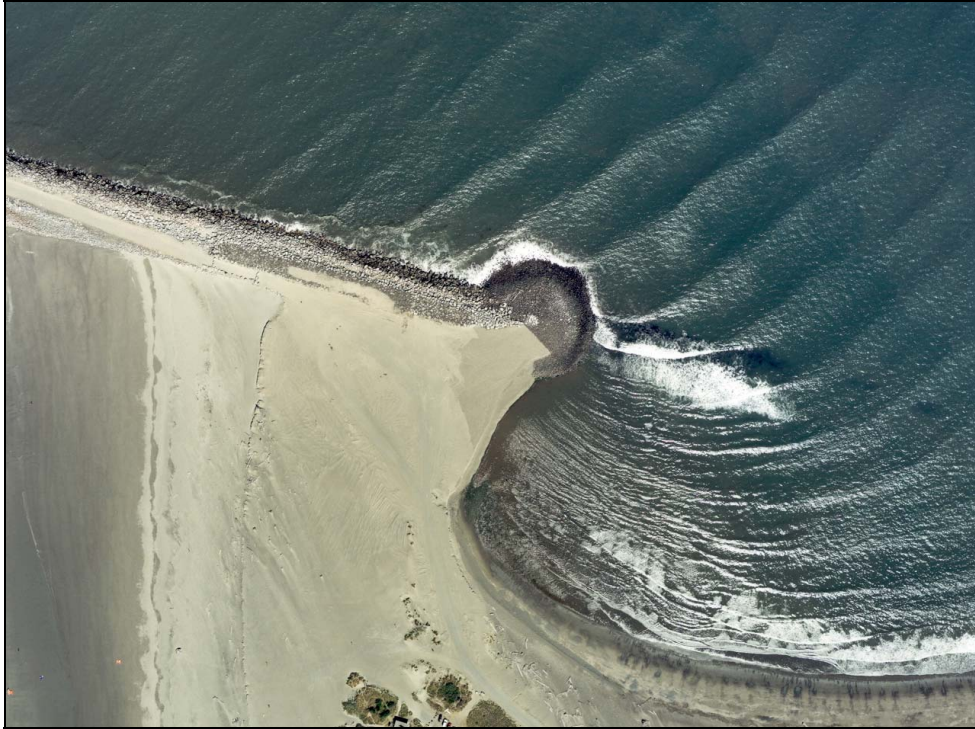
Figure 11. Mound diffraction structure as constructed at Grays Harbor, WA (2000)

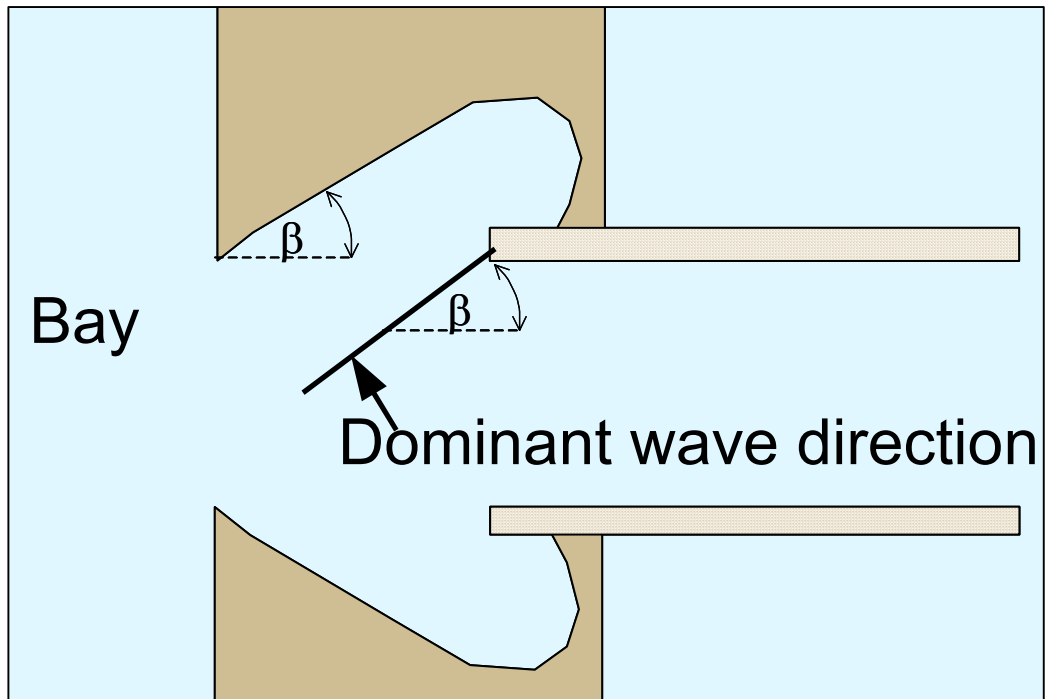
Figure 12. Equilibrium inner-bank erosion showing dominant wave angle and shoreline orientation angle, β

ANALYTICAL EVALUATION: Analytical expressions for the shape of an equilibrium inner-bank eroded region can be adapted from work developed for shapes of headland-bay beaches. Originally log-spiral curves were developed to fit the beach shape, but more recent work indicates parabolic or quadratic equations can represent the equilibrium form well (Silvester and Hsu 1993). Charts are also available (Silvester and Hsu 1993) which relate the indentation, to elongation ratio of an embayment to the dominant wave angle β , which, once equilibrium is reached, is the angle that the downcoast portion of the shoreline makes with the original shoreline. Figure 12 shows β for the case of inner-bank erosion. These analytical methods were developed for the open coast, but it appears reasonable to use, with caution, these techniques for inner-bank erosion. As was noted in the physical model tests discussed earlier, the effect of currents (especially flood current) and increased water level, can increase the size of the equilibrium eroded area. The dominant wave angle β can be fairly small for a large inlet, high-wave-energy system, such as Grays Harbor. Dominant wave angles compare with those for open coast angles for such large inlet systems. For smaller, narrow inlets, the wave angle will be larger, and less confidence should be placed in these analytic techniques.
